# D&D of a Former Beryllium Machine Shop

Gary E Whitney, CIH

Los Alamos National Laboratory

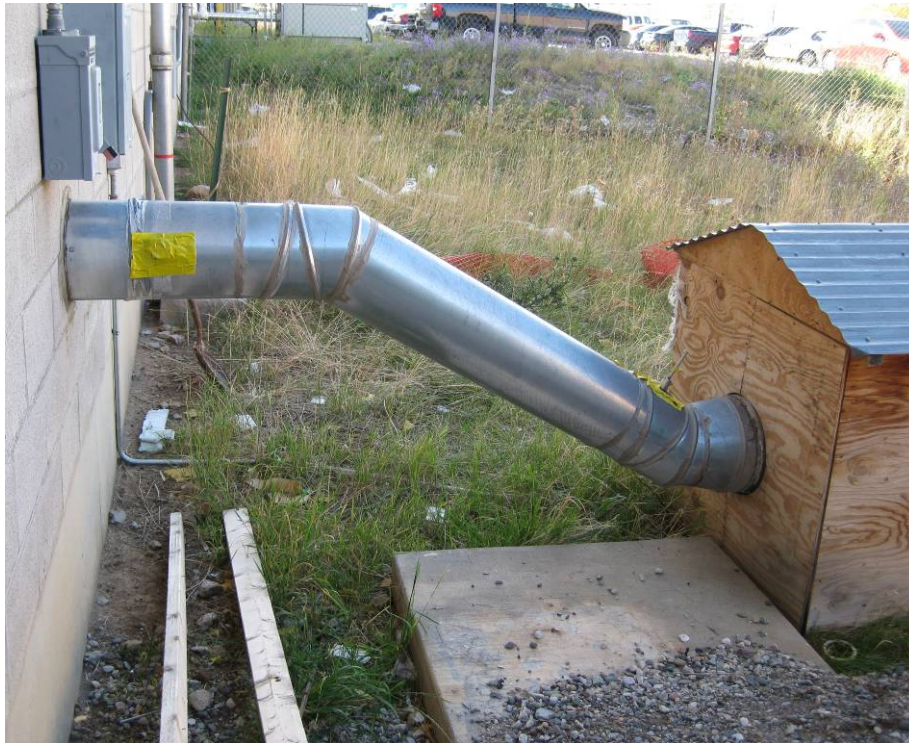
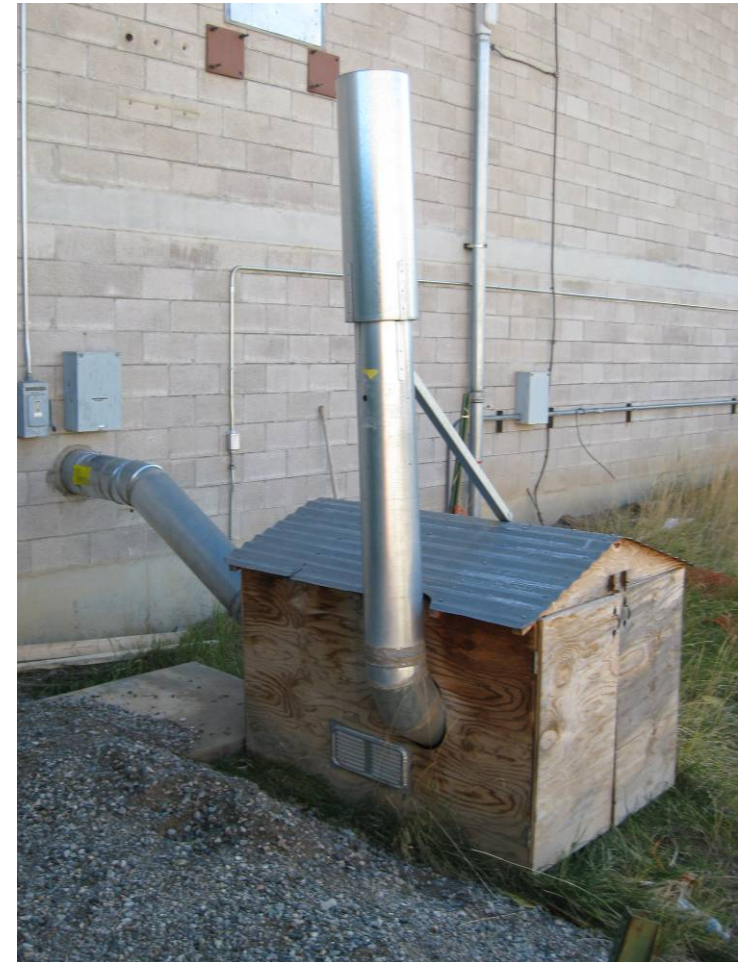
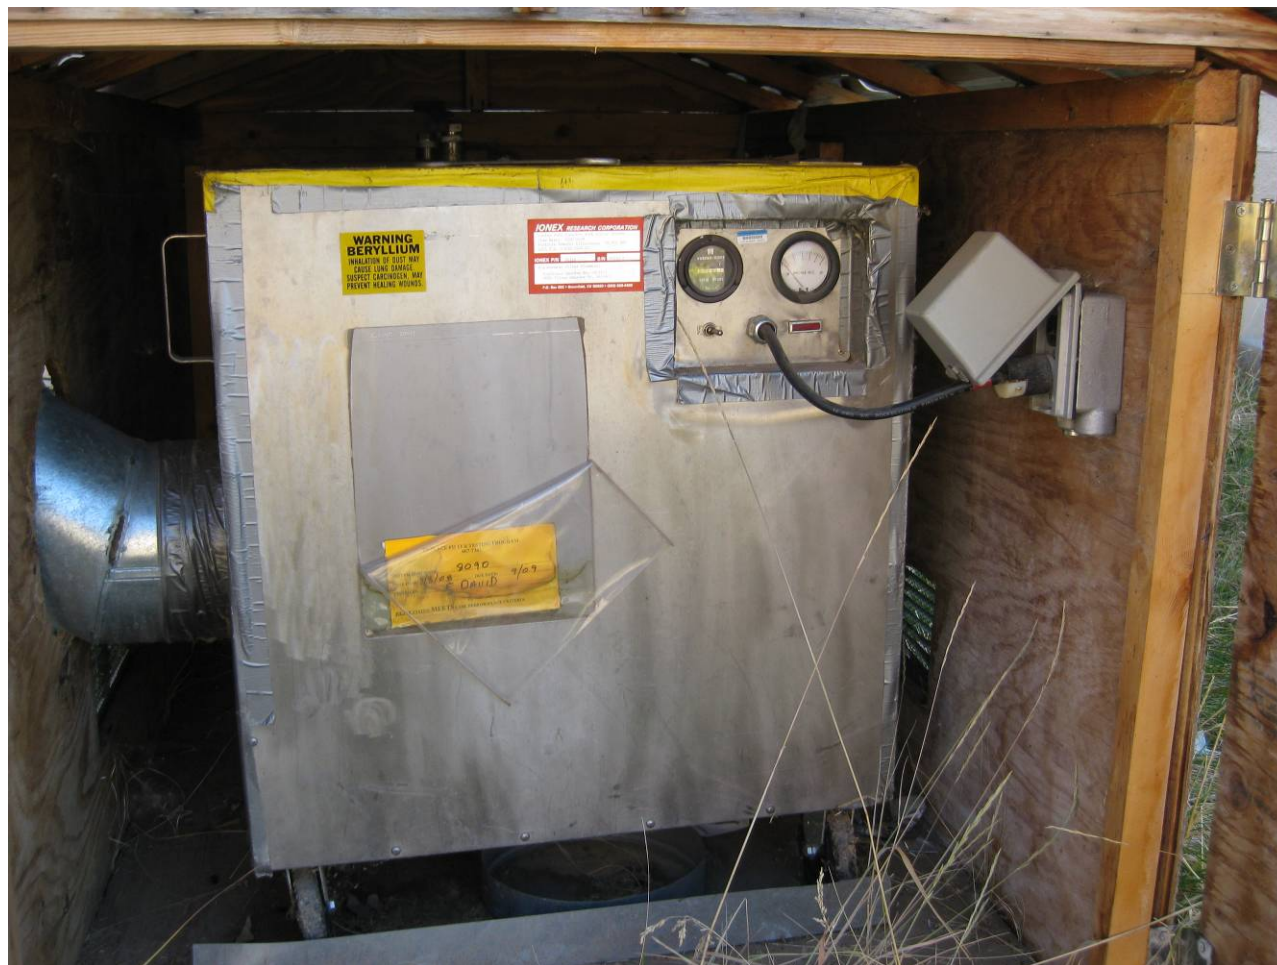
- A problem with the dynamic precipitator in 2000 required a ventilation system shutdown for repairs.
- Ventilation system normally on 24/7 to keep shop negative in respect to hall. Concerns of contamination spread.
- Solution was a HEPA clean-air machine (~800 cfm) installed outside building and connected via a duct through the wall.
- This additional ventilation was not installed as part of this project, but it certainly provided an advantage and should be considered for similar jobs.

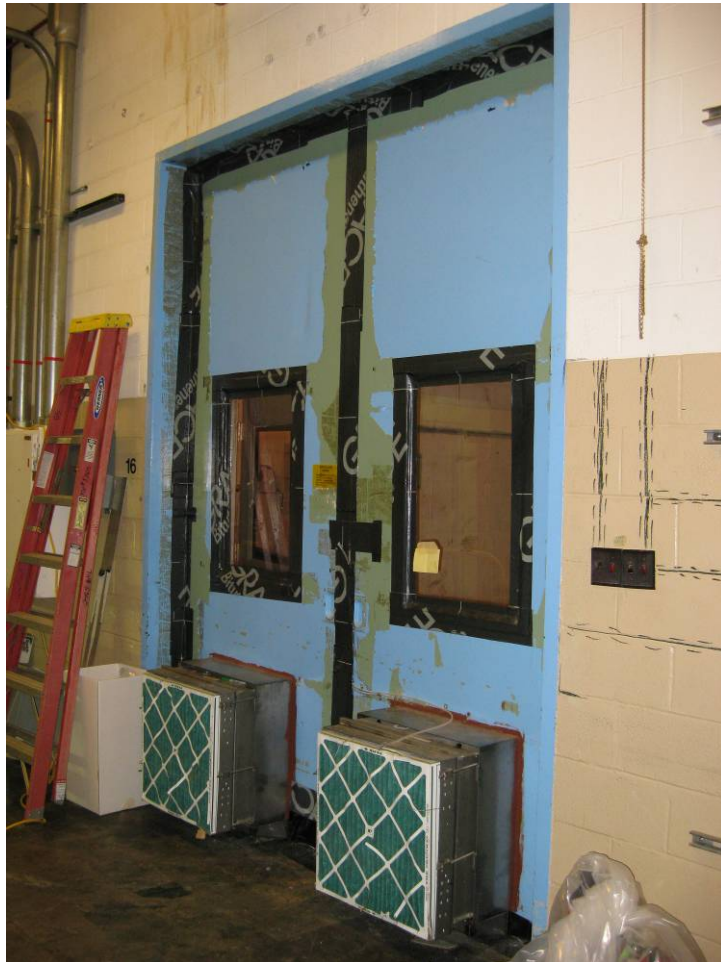
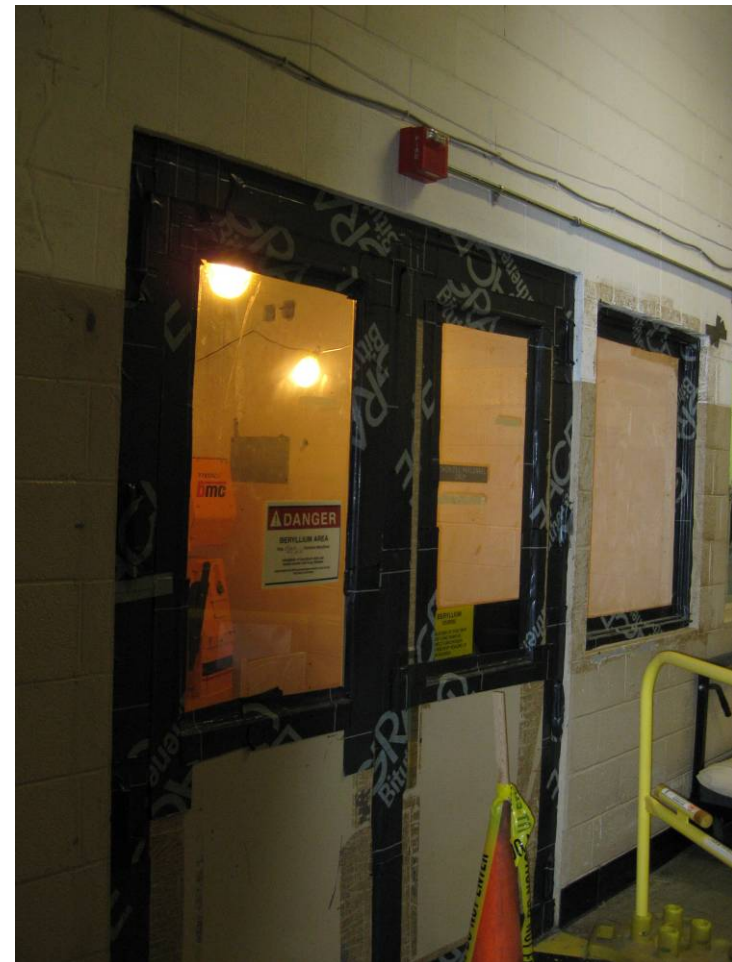
# Sealing Shop Doors and Windows

- When in operation the beryllium machine shop had daily cleaning; routine surface wipe samples were collected; ventilation system was checked daily; and air samples were collected for all machining operations.
- All this served to constantly monitor the situation and control contamination spread.
- Concerns were raised over how to maintain control when the shop was no longer operational and unoccupied.
- Chosen solution was to seal in the shop.

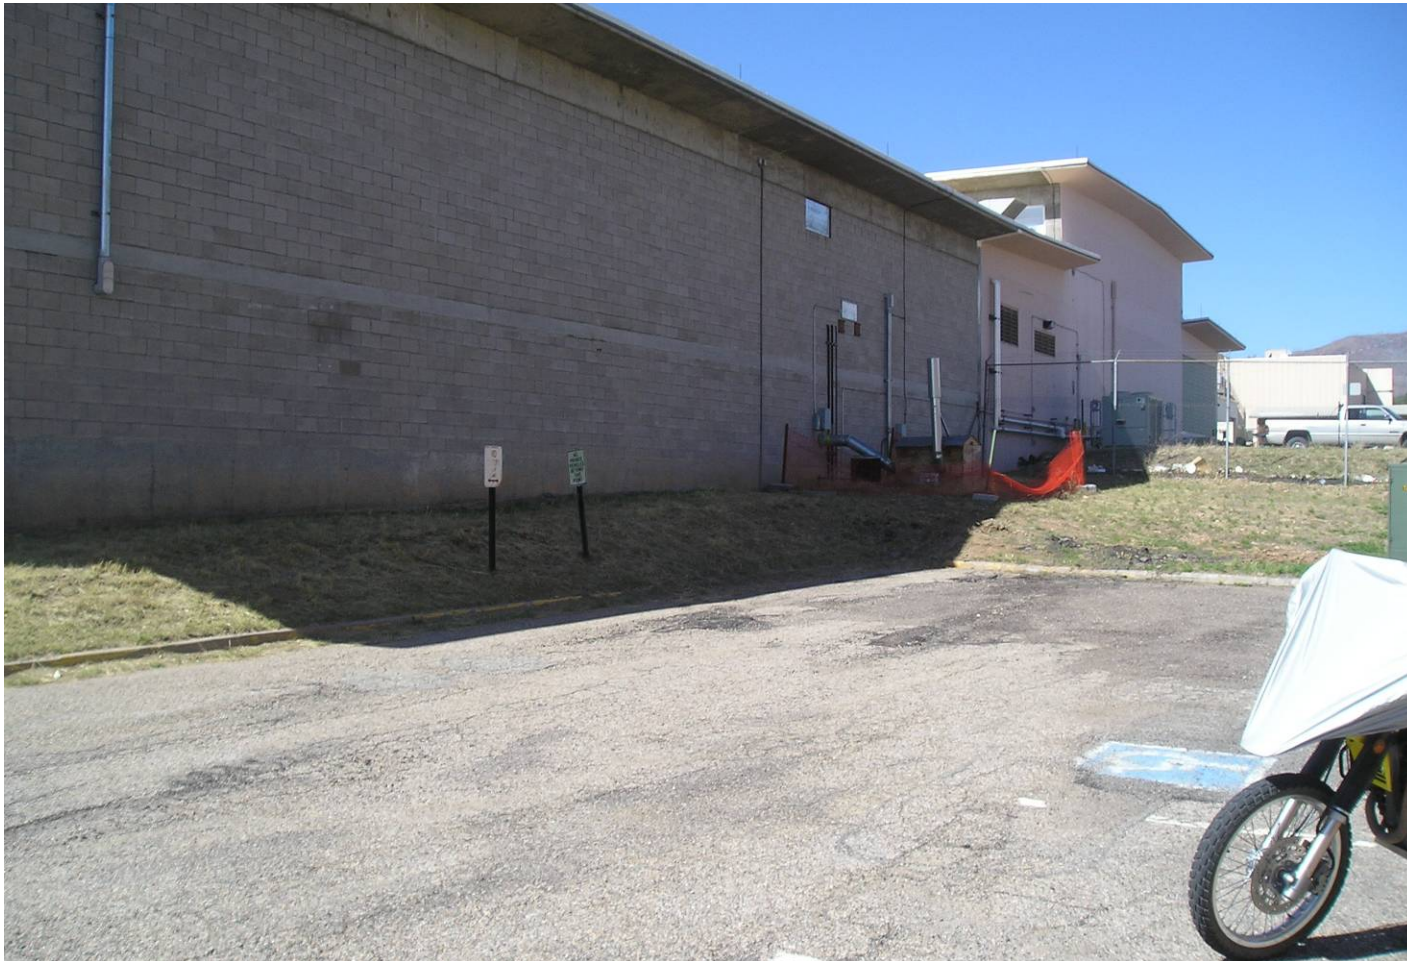
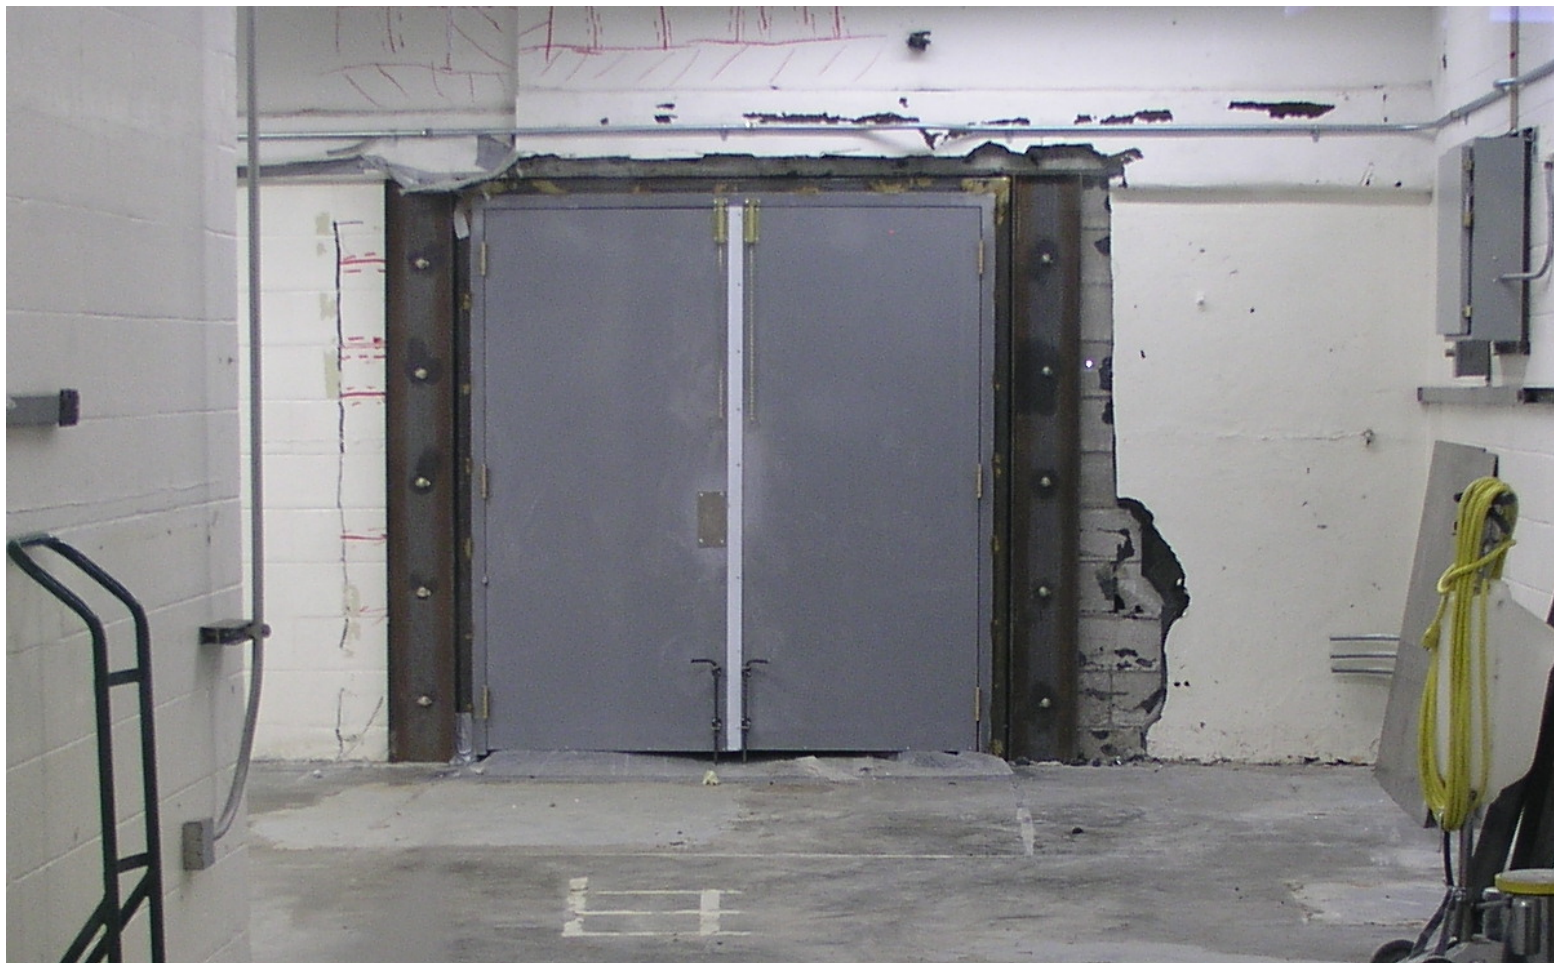
How do we get this stuff out of here?
